Incorrect Temperature Measurements: “The Importance of Transmissivity and Infrared Windows”

By Martin Robinson, CMRP Level III Thermographer President, IRISS Inc.

Official Report Excerpt: Summer 2009

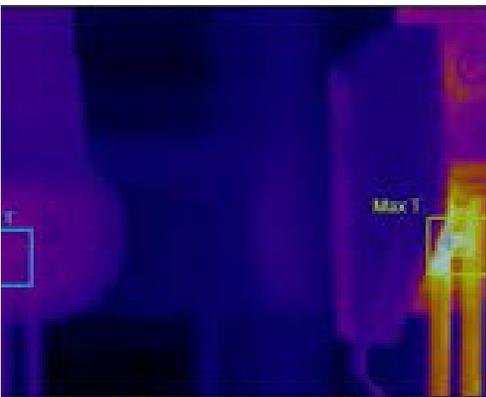
I reported the following to the PM: Isolation switch number one (Switch# 1) has a 30°F ΔT on the "C" phase Disconnect contact.

Image 1 Max T 154.1 °F, Ref T 123.9 °F,
Delta T 30.19 °F

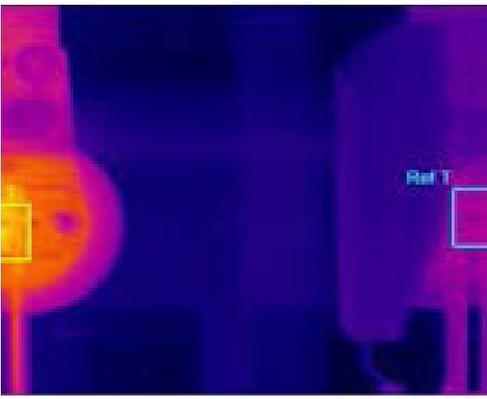
Isolation Switch Number Two (Switch 2) has two hot spots: the first anomaly (21 °F ΔT on the Phase "A" Disconnect contact (Image 2).

Image 2 Max T 145.0 °F, Ref T 124.8 °F,
Delta T 21.19 °F

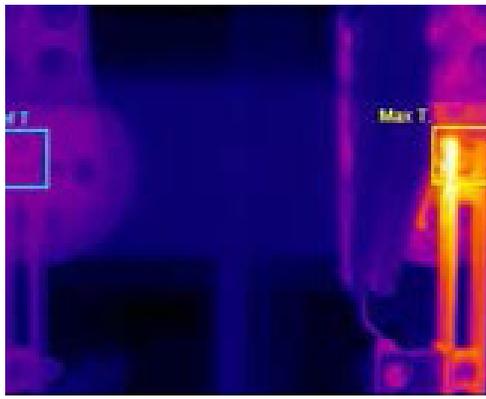
Image 3 Max T 179.6 °F, Ref T 119.1 °F,
Delta T 60.54 °F

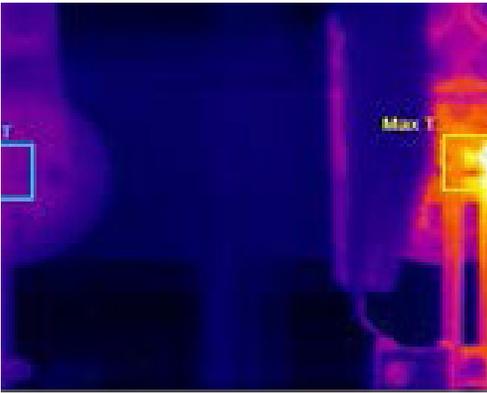
Image 4 Max T 146.9 °F, Ref T 117.3 °F,
Delta T 29.51 °F

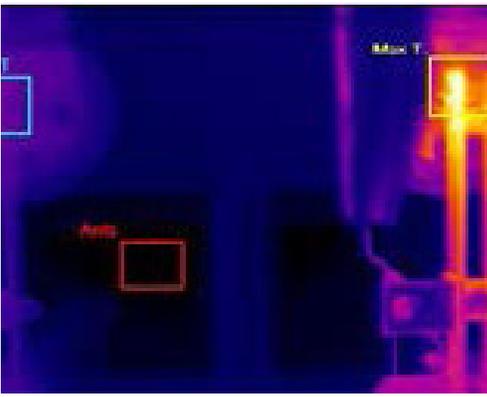
The next morning, Thursday, I came in early and scanned the equipment before sunrise. I found and reported that Switch No. 1 had increased to nearly $75^{\circ}\text{F } \Delta\text{T}$. (Image 5) This anomaly had risen 150% in just 3 days!

Image 5 Max T 211.2 °F, Ref T 137.4 °F, Amb 118.6 °F, Delta T 73.73 °F

I captured the images and send out the report. In less than an hour a meeting was held. Reports were sent, calls were made, and the corporate office got involved. Management ordered a decrease in the production rate immediately. No one was willing to let a 75°F ΔT remain in the Incoming Power switch that fed half of the plant. Not on their watch.

The plan was to take Switch #1 offline during a 2 hour power outage that evening. As is sometimes the case, paperwork and part acquisition delayed the repair. Finally, the switch was thrown around 2:00AM Friday morning.

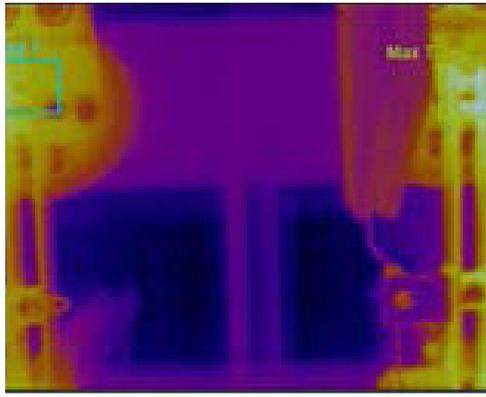
Image 6 Max T 110.9 °F, Ref T 110.0 °F, Delta T 0.92 °F

I arrived on site Friday morning just as the electricians were clearing locks and tags and preparing to bring the switch back on line. After the switch was loaded, I scanned the anomaly and reported that Switch #1 appeared to have no hot spots. Repairs, though costly, were successful.

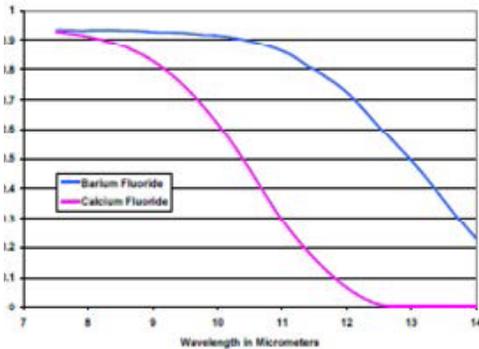
Transmission Curves for Barium Fluoride and Calcium Fluoride in micrometers

According to the report, transmission rates are typically variable across the infrared spectrum (as shown in Madding, 2004 1), yet the manufacturer's specified transmission rate is generally relevant for a specific wavelength. So, while a Crystal may indeed have a 95% transmission rate in the short wave, most industrial IR camera operate in the long-(mid) wave or 8-14 μm .

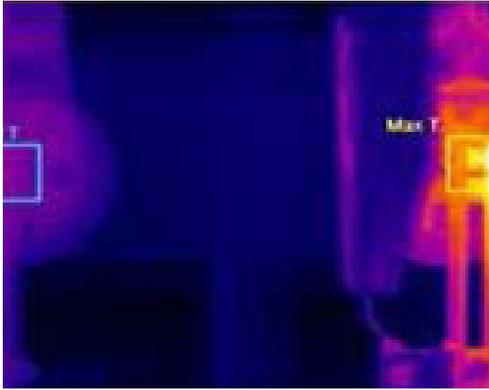
Image 8 Max T 146.9 °F, Ref T 117.3 °F, Delta T 29.51 °F

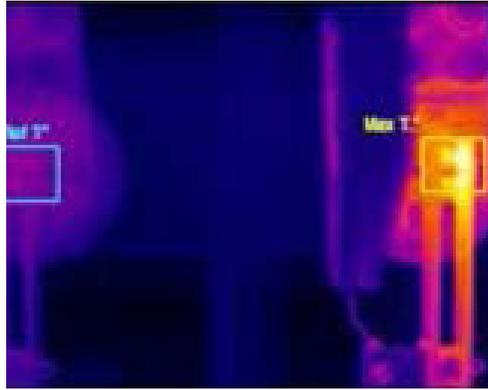
Image 9 Max T 191.8 °F, Ref T 147.5 °F, Delta T 44.29 °F

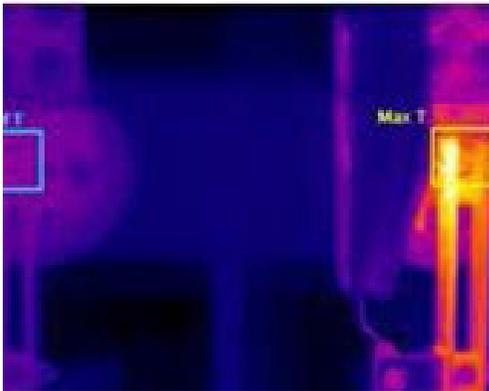
Image 10 Max T 176.6 °F, Ref T 119.1 °F, Delta T 60.54 °F

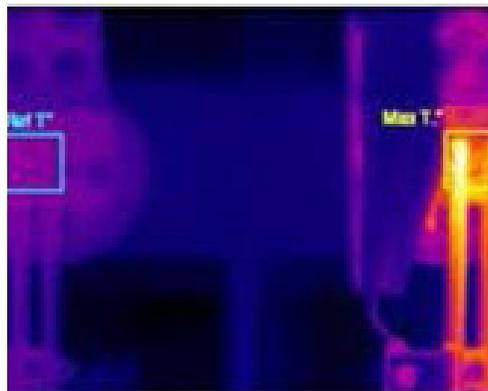
Image 11 Max T 239.7 °F, Ref T 150.2 °F, Delta T 89.52 °F

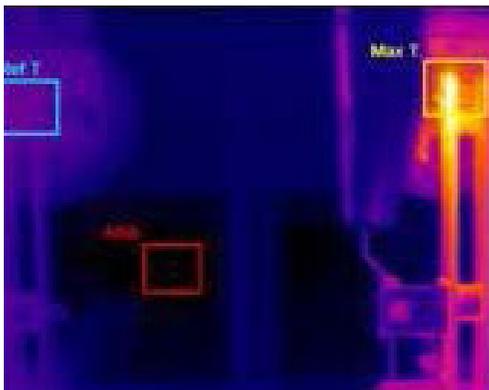
Image 12 Max T 211.2 °F, Ref T 137.4 °F, Amb 118.6 °F, Delta T 73.73 °F

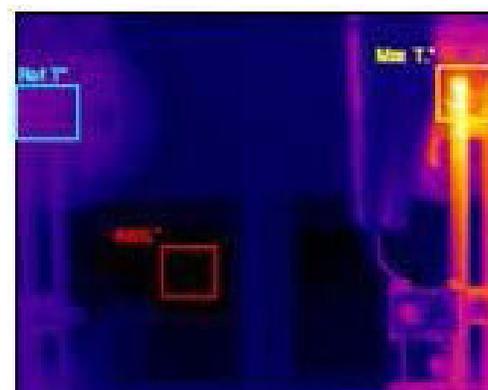
Image 13 Max T 285.1 °F, Ref T 177.6 °F, Amb 149.4 °F, Delta T 107.24 °F
