Case Study

A Multi-Tenant 600,000 Square Foot Commercial Office Building in Jersey City, NJ.

By Martin Robinson, CMRP Level III Thermographer President, IRISS Inc.

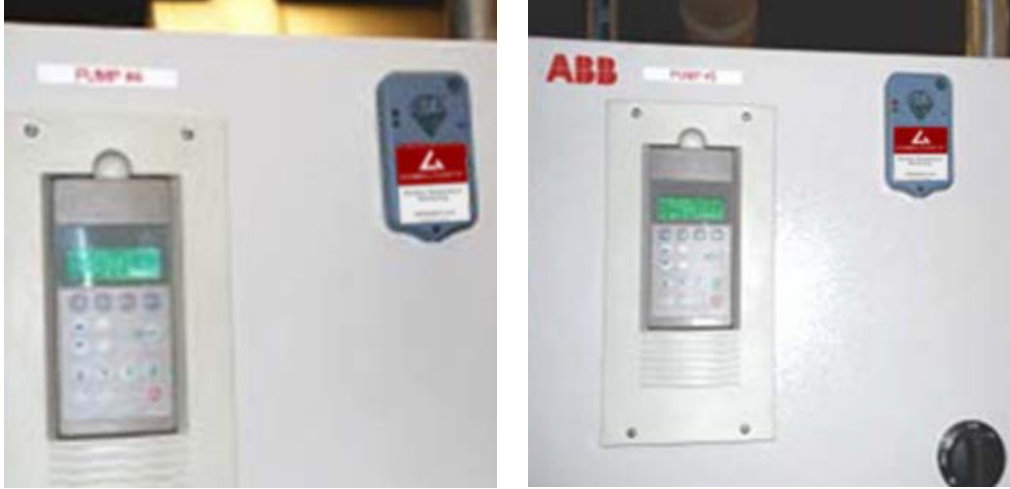
Figure 1 Delta T Alerts installed on VFD's P-4 and P-5.

Delta T Alerts were installed on both units (Figure 1). The site's Chief Engineer tested and recorded temperatures at two VFD's labeled P-4 and P-5.

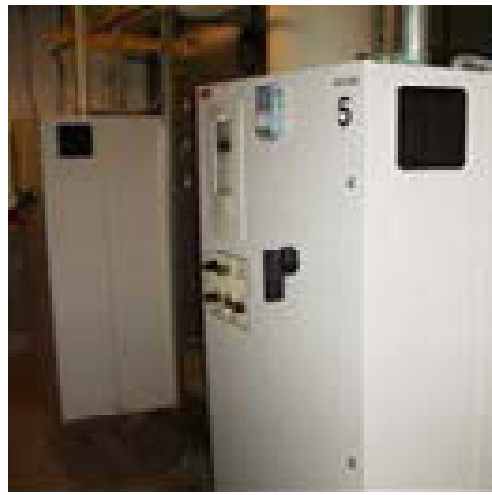
Figure 2 Thermographic and visual image documenting normal operation of VFD.

After the Delta T Alerts were installed, temperature data was collected under normal operating conditions (Table 1). Additionally, a thermographic and visual image was collected of the external VFD to document the cover panel temperature measurements (Figure 2 and Table 2).

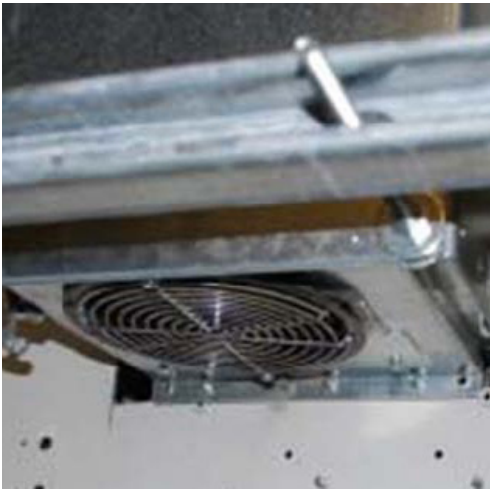
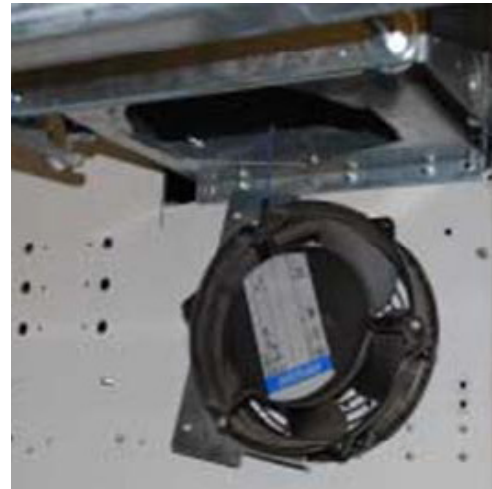
Figure 3 Documenting the disconnection and fan removal from VFD unit P-5.

The Chief Engineer removed the fan from P-5 VFD (Figure 3) and took thermal readings of both VFD's after 30 minutes of operation at 45 Hertz (Figure 4 and Table 3) concluding that fan failure results in an overheated VFD resulting in premature VFD failure.

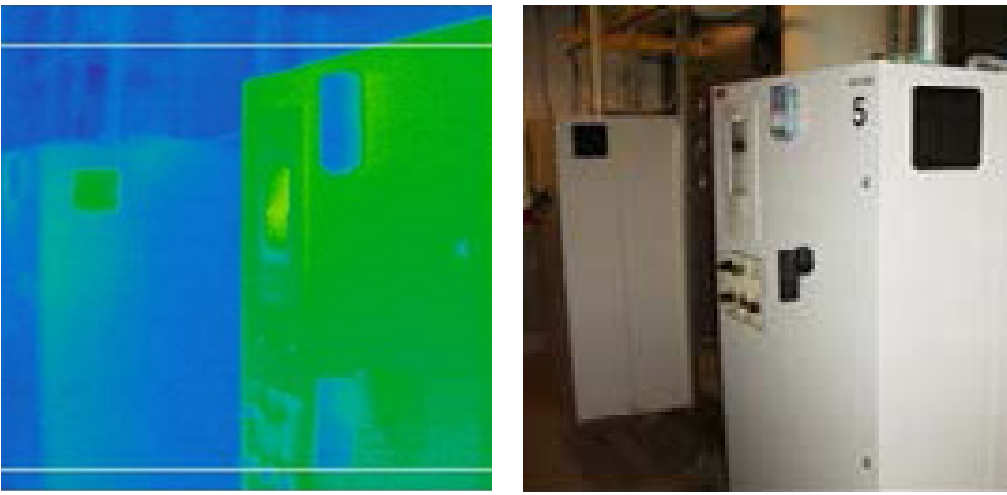
Figure 4 Thermographic and visual image documenting increased heat of VFD P-5 after fan removal.

VFD #	Operating Hertz	Room Ambient Temperature	Internal VFD Temperature Recorded by Delta T Alert
P-4	45	77°F	97°F
P-5	45	77°F	117°F
