OSHA and NFPA 70 Transmission Stability and Infrared Windows: “The Effects of Transmissivity on Data Accuracy”

By Martin Robinson, CMRP Level III Thermographer President, IRISS Inc.

Abstract:

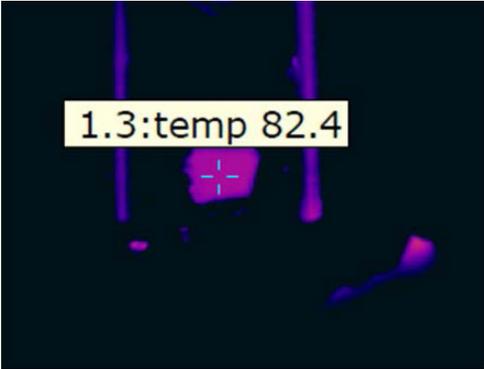
Thermogram 1.3 shows the same target through the CaF2 Test Window, with the τ set to 0.49 per the baseline established when it was new. However, in this case the apparent temperature registers as 82.4°F (28°C), resulting in a 33.5°F (17.6°C) or 28.84% error between apparent and true temperatures.

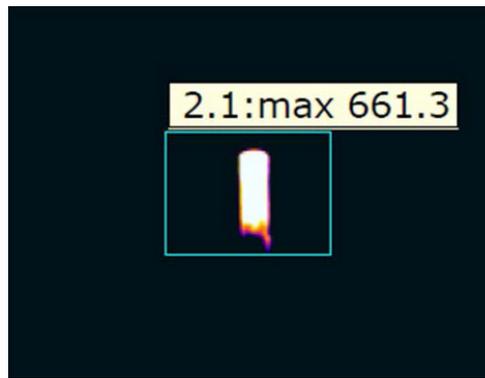
Thermogram 2.1 shows the thermal image of the soldering iron tip with no infrared window. The target temperature is shown to be 661.3°F (349.6°C). We will define this as the true temperature of the target.
