Insurance Company Chooses IRISS Infrared Windows for Arc Flash Mitigation Campus Wide

By John Zyzomyrsky, CFPPS, Level 1 Thermographer, for IRISS Inc.

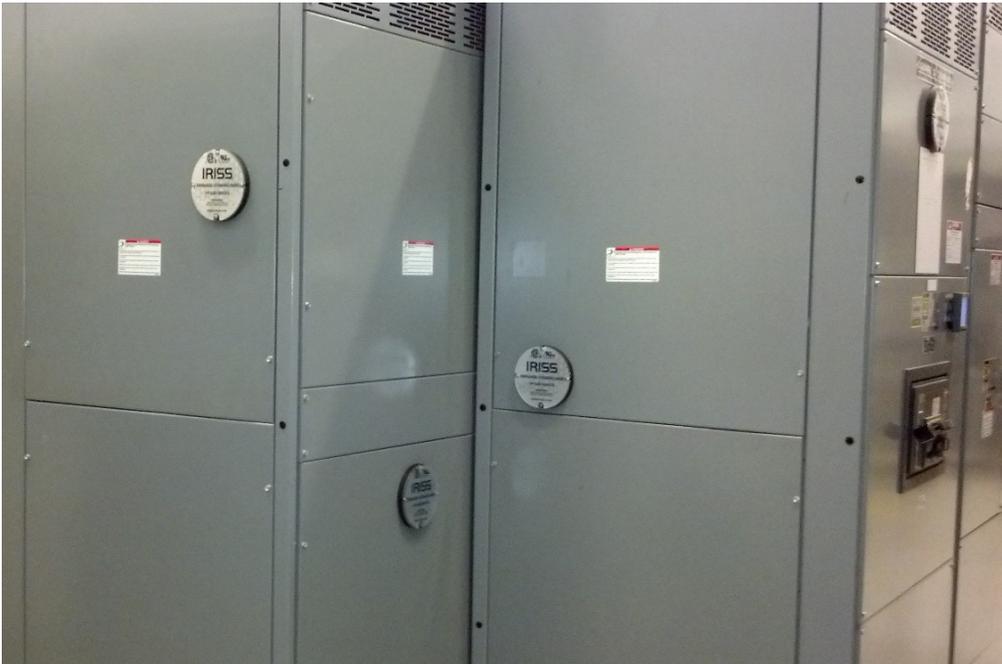
It was decided to install VPT Series 3" and 4" round IR windows as well as CAP Series 12" and 24" rectangular windows throughout the substations and switchgear. Installation of 150 IR windows was completed in less than 12 hours on 208V / 480V substations ranging in size from 500 Amp to 4000 Amp as well as on 11kV fused switches and cable termination boxes. Much of the electrical gear was located in the basement under damp conditions.

IR surveys now only take one thermographer in his street clothes and safety glasses compared to one thermographer and two electricians in full 40cal/cm2 Personal Protective Equipment (PPE) to open the panels and perform the inspection work. Labor Cost savings of over 90% have been realized while not exposing electricians and technicians to energized equipment. The insurance company is now able to perform their CBM with greater frequency and dramatically increasing the discovery of electrical anomalies before they become critical.
