The Critical Angle of Ultrasonic Electrical Inspection of Transmission Lines and Enclosed Systems

By Drew Walts, Level 2 Certified Ultrasound Technician, SME, Training Manager, IRISS Inc.

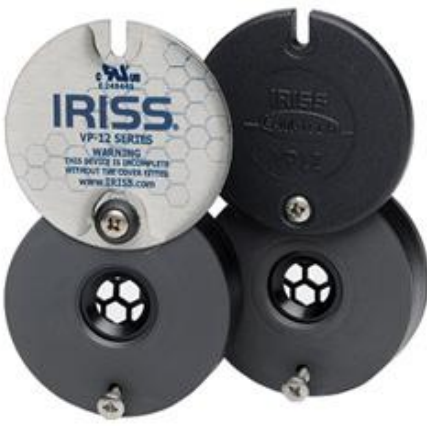
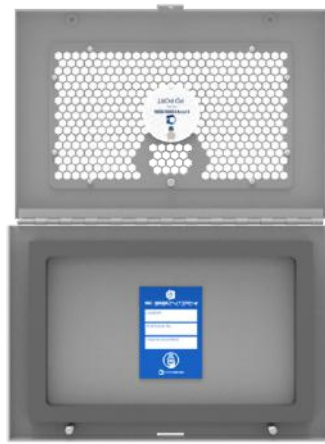
Figure 10 Dedicated Ultrasound Ports and IR Windows with Embedded Ultrasound Ports

When inspecting equipment with ventilation openings, the inspector can sometimes get a better angle through these openings. By simply changing the positioning of the module, the inspector can try to pinpoint the area where the emission is originating from. If the asset is totally enclosed and there are no ventilation openings, the use of a dedicated Ultrasound Port (e.g. IRISS VP-12-US) or an Infrared Window with an Ultrasound Port (e.g. IRISS CAP-ENV-PD Series) will insure the truest form of the emission can be recorded with minimal diffraction. These ports are significantly more effective than scanning the seam on enclosed systems.

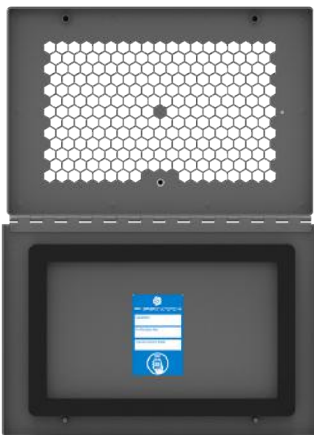
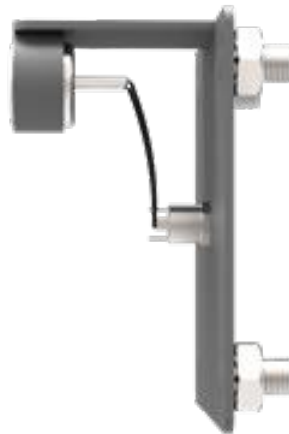
Figure 11 IR Windows with Built in Partial Discharge Sensors can be used to gather Ultrasound Data on Closed Systems

Some electrical assets have hermetically sealed cabinets and the use of an Infrared Window with a built in Partial Discharge Sensor like the IRISS CAP-CT-PDS or CAP-ENV-PDS Series is the best choice. With a transducer mounted inside of the cabinet, the inspector can eliminate antagonistic ultrasound from nearby defective lighting ballasts, ultrasonic motion sensors for lighting & security and from other sources generated by the everyday noises in production areas. Adapter cables allow a handheld Ultrasound tester to plug into the PDS ports are available.
